# DEWATS FOR SUSHMA KOIRALA HOSPITAL

Sankhu, Kathmandu, NEPAL

## Project Background

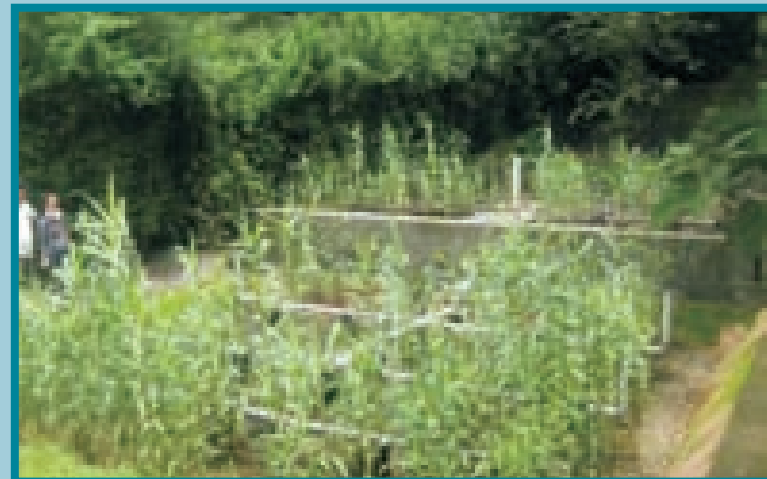
Source	Hospital Wastewater
Design Capacity	15-20m <sup>3</sup> /d
No. Users	Designed for 250 patients,
Peak flow	20m <sup>3</sup> /d
Influent Quality: Dec 2010	BOD 450mg/L
COD	832 mg/L
Effluent Quality: Dec 2010	BOD 70mg/L
COD	159mg/L
Efficiency	84% BOD, 81% COD

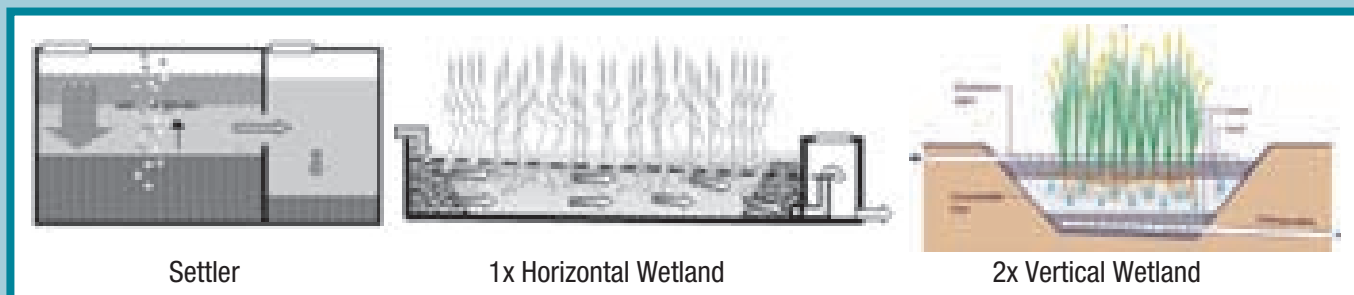
## Typical Drawing of Components

<b>Settling Tank – 1 unit</b>	
Chambers	3 baffle walls
Area Construction	9m <sup>3</sup>
Depth	1.5m approx
<b>Planted Gravel Filter: 1 Horizontal Bed</b>	
Surface Area	65m <sup>2</sup>
Depth	0.6m average
Filter Material	Gravel
Plants Used	<i>Phragmites karka</i>
<b>Planted Gravel Filter: 2 Vertical Beds</b>	
Surface Area	70m <sup>2</sup> each
Depth	0.6m average
Filter Material	Gravel
Plants Used	<i>Phragmites karka</i>
<b>Total Area</b>	200m <sup>2</sup>
