DEWATS FOR DHULIKHEL HOSPITAL

Dhulikhel, NEPAL

Background

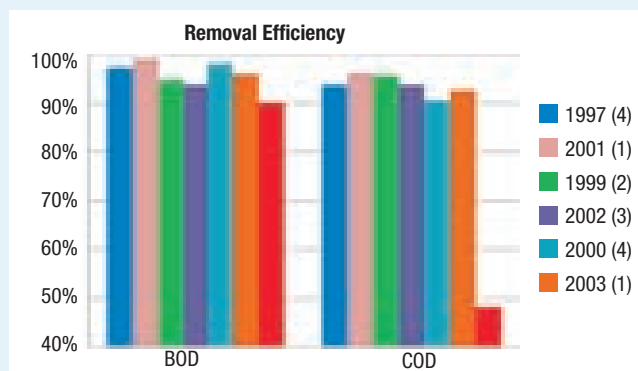
Data from July 2010

As the Aamaghar DEWATS unit has just been established, the previous DEWATS system had been monitored regularly since 1997 and generally performed well. The results of a survey in July 2010 shown in the table and graph indicate the current system is still performing fairly well but these results were impacted by monsoon rain and blockage of a system.

Parameter	Influent	Effluent	% change
pH	7.1	7	NA
TP (mg/L)	2	3	-50%
TN (mg/L)	19.5	16.5	15%
TSS (mg/L)	55	5	91%
Oil & Grease (mg/L)	3.6	12	-233%
BOD5(mg/L)	60	6	90%
COD (mg/L)	432	223	48%
DO(mg/L)	4	0	100%

Influent Quality (July 2010)	BOD 60mg/L COD 432mg/L
Effluent Quality (July 2010)	BOD 6mg/L COD 223mg/L
Efficiency	90% BOD, 48% COD
